Antifouling Efficacy

Domestic Marine Testing of CeRam-Kote™ AF Marine Coating

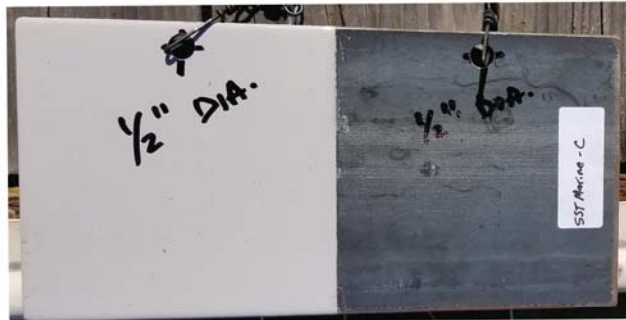
Before Immersion

Continuous submersion in shallow boat basin extension from San Diego Bay with low tidal flushing action. Samples suspended at average depth of 18 in.

A steel panel (right side) was half coated with CeRam-Kote™ AF Marine Coating (left side). The panel was subjected to 90 day continuous submersion in the waters of San Diego Bay from February 22, 2020 until May, 22, 2020. The water was a shallow boat basin extension from the bay, with low tidal flushing action.

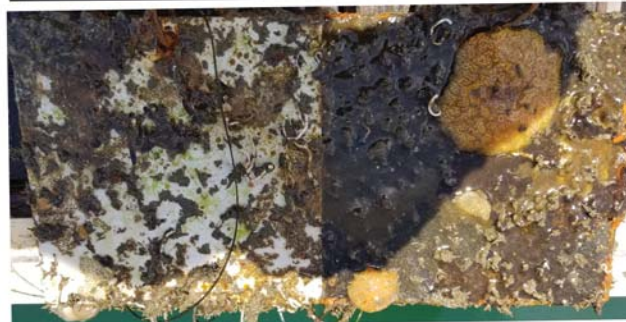
After 90-days immersion showing marine plant growth

There are no barnacles or other hard marine growth present on test sample, except for a few coral worms not visible

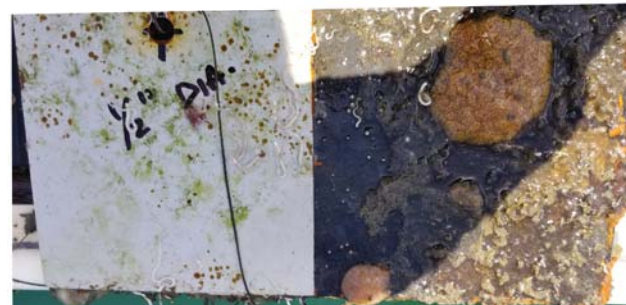
After rinsing with dock hose at residential pressure

The only debris present were marine growth stains and a few coral worms which were easily popped off with plastic putty knife. Standard vessel operation would likely yield enough rinsing action to create similar results on painted hulls.

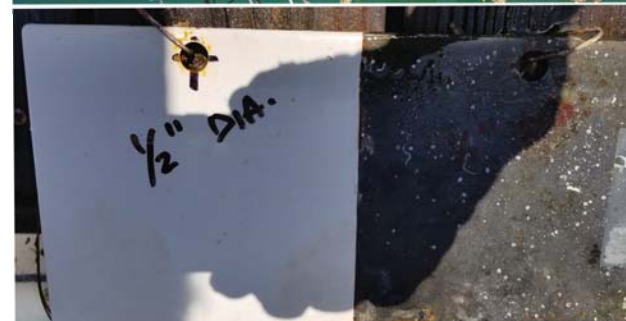
After light wiping with kitchen sponge

Virtually like new condition. Standard vessel operation would likely yield enough rinsing action to create similar results on painted hulls.
